BEFORE YOU BUY

Building and Timber Pest Inspection Report

Property Address: Queensland, Australia

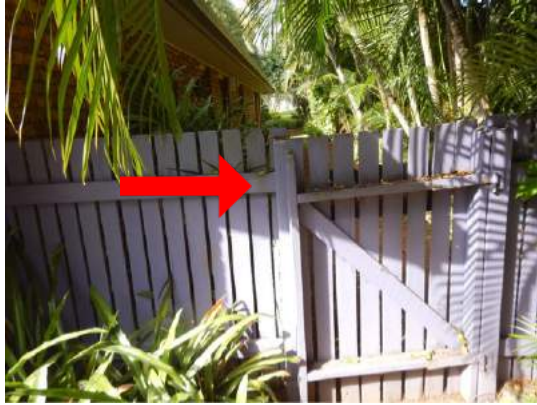
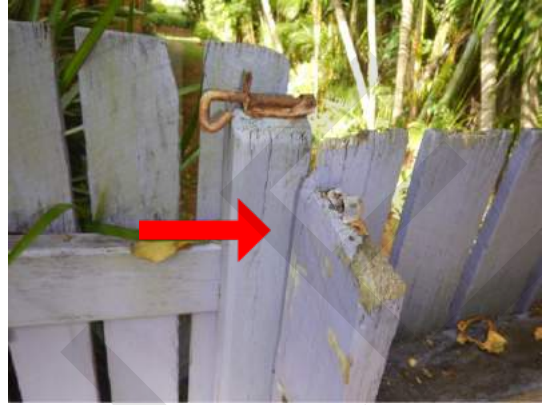
Finding 3.01

Location: Yard - Back

Finding: Fencing - Deteriorated

Information: It was noted at the time of inspection that sections of the fencing throughout the property have deteriorated (gates not closing and palings missing). Typically fencing deteriorates due to age and or wear, rot and or rust which is generally expected for a structure of this age, due to prolonged exposure to weather conditions. Sometimes inadequate installation or maintenance can be to blame.

If left unattended, it is likely that further damage will occur. It is suspected that repair of several elements of the fencing may be required however replacement may be a consideration of the client also.

A licensed fencing contractor should be appointed to provide further advice and perform rectification works as necessary.

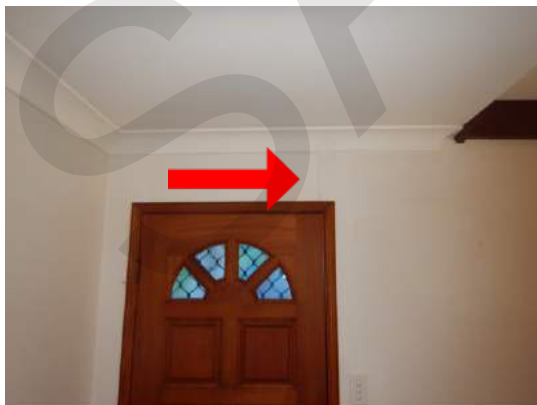
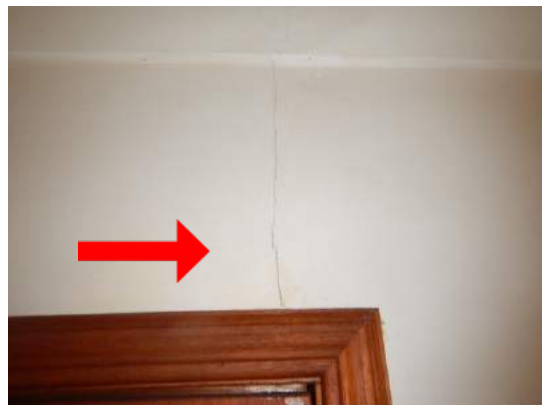
Finding 3.02

Location: Entry

Finding: Cracking - Damage Category 0 - Hairline (less than 1mm)

Information: Hairline cracks are very minor in nature and generally are only ever an appearance defect. While such cracking may be noticeable in some cases, it is quite common and does not indicate any structural damage.

Cracking of this nature can generally be repaired with minor sanding, filling and/or repainting. Such works should be performed by a qualified painter or a general handyman.

Monitoring of all cracking should be conducted frequently. Always contact a building inspector should cracks widen, lengthen, or become more numerous.

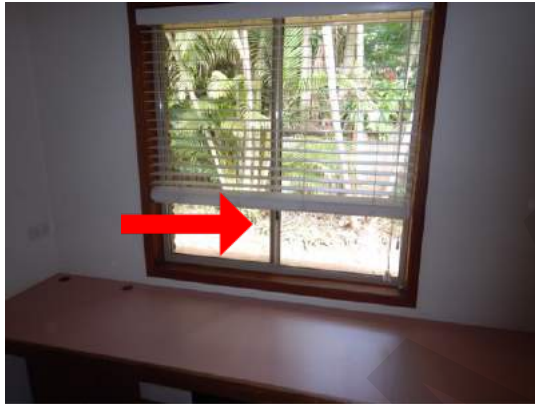
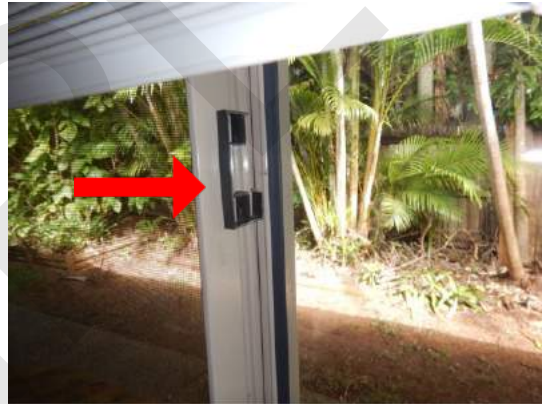
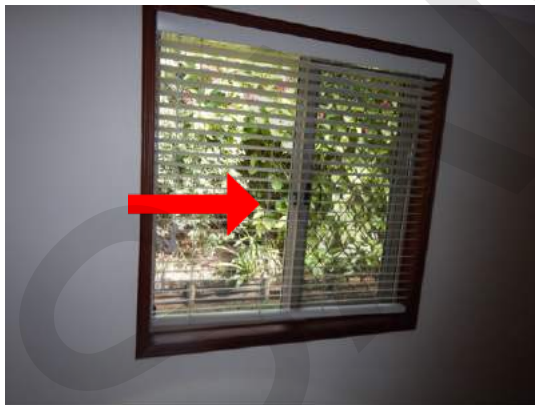
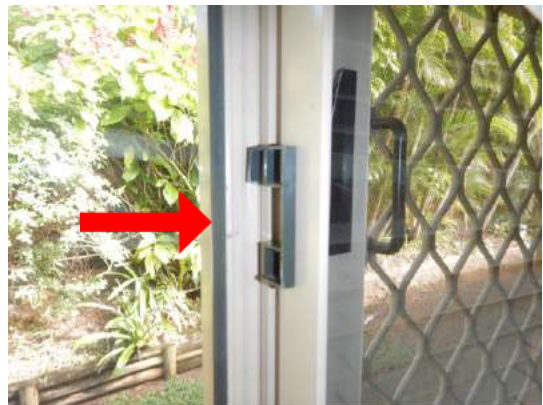
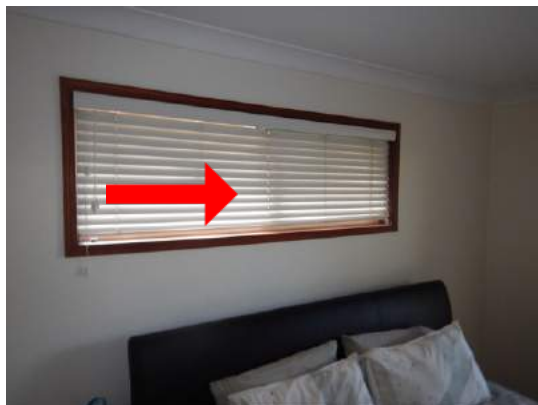
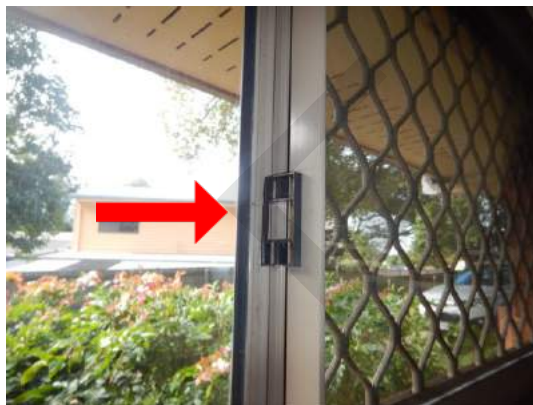
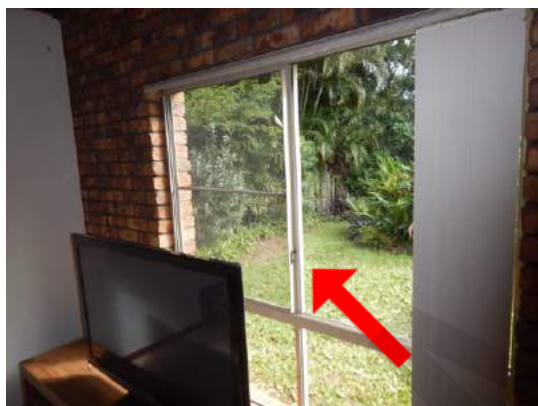
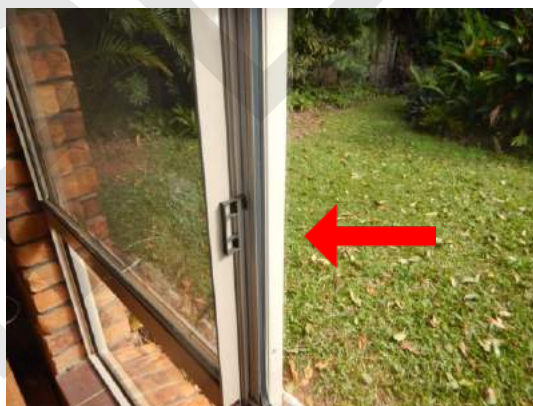
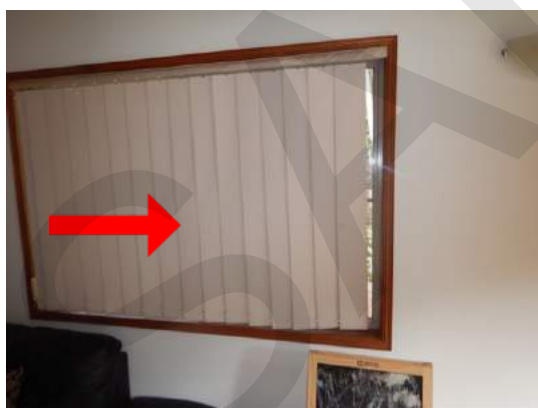
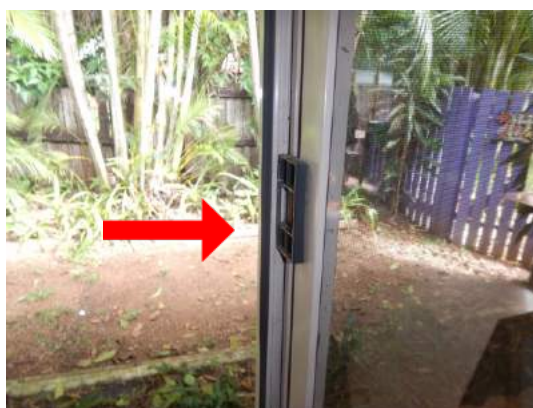
Finding 3.03

Building: Main Building
Location: Internal Areas
Finding: Window - Missing handle
Information: The handle to the window was missing at the time of the inspection. Absence of the handle limits the operation of the window and may pose as a security risk.

Replacement of the handle should be conducted as soon as possible. A general handy person or window installer should be appointed to perform these minor works to improve the operational state of the affected window and improve the security of the internal area.

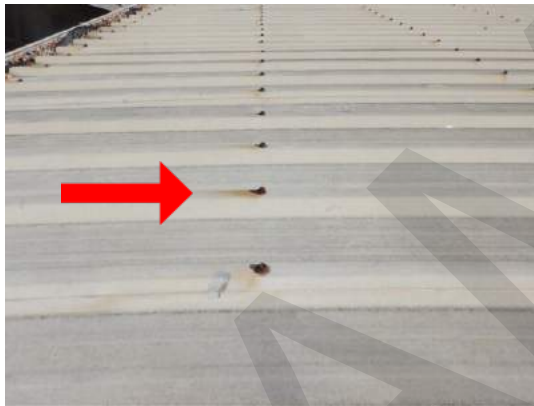
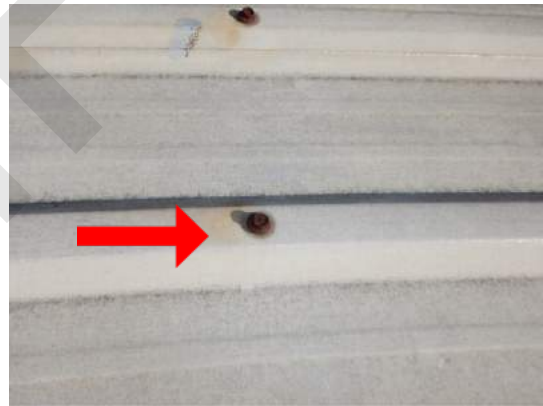
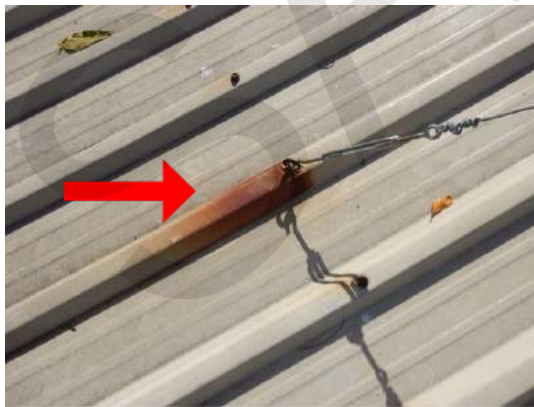
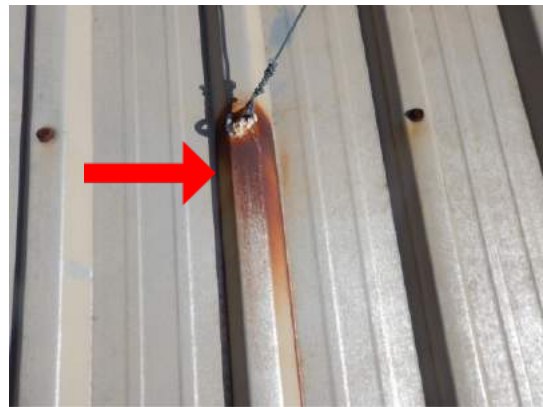
Finding 3.04

Building: Main Building
Location: Roof Exterior
Finding: Roofing - Minor Surface Rust
Information: This building element shows evidence of rusting and corrosion, which is likely to have developed as a result of inadequate coatings..

As surface rust provides no protection to the underlying iron, the deteriorating condition is likely to worsen if not addressed in the short-term future.

Where possible, the use of galvanized (treated) metals or aluminium coated metals aid in rust prevention, as does regular general maintenance. Rust formation can be controlled with coatings, such as paint, that isolate the iron from the environment.

Rusting and corrosion should be managed by ideally removing or limiting the affected surface from exposure to moisture. A painter may be appointed to undertake these works.

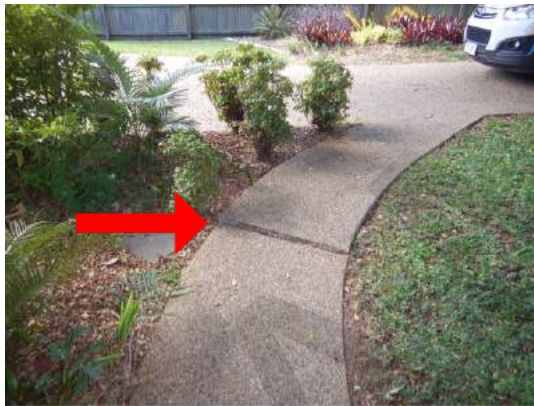
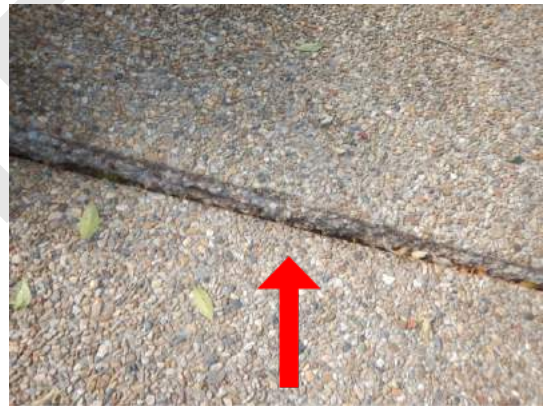
Finding 3.05

Building: Main Building
Location: Path - Front
Finding: Cracking - External Concrete Paving Damage
Information: Cracks or movement was identified in external concrete paving in this location at time of inspection.

Expansion and contraction of the slab may have occurred due to environmental factors. Such factors include variable moisture and weather conditions, the presence of trees and their roots having a settling or lifting affect on the soil.

Cracking to this degree may also be due to poor original installation of the concrete. Factors such as poor compaction of the sub surface and/or inadequate reinforcing of the slab may create cracking and other secondary defects.

Minor repairs such as grinding of the pavement is at the clients discretion.

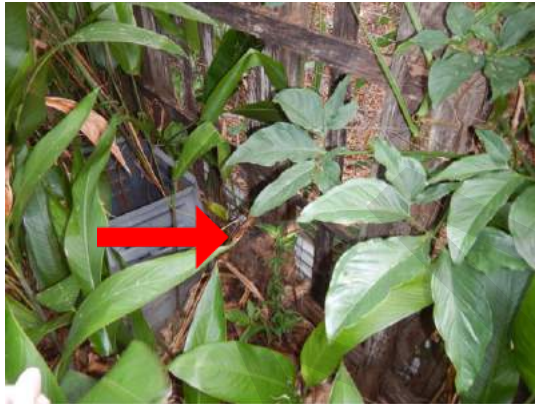
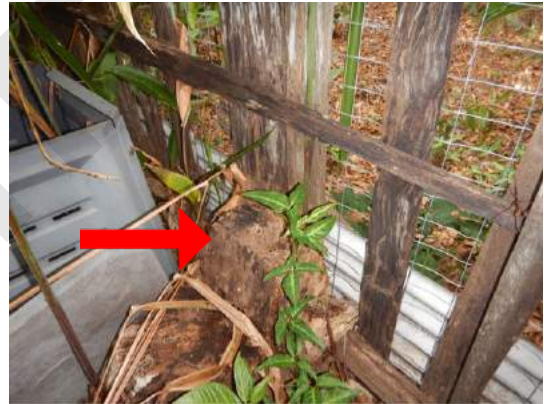
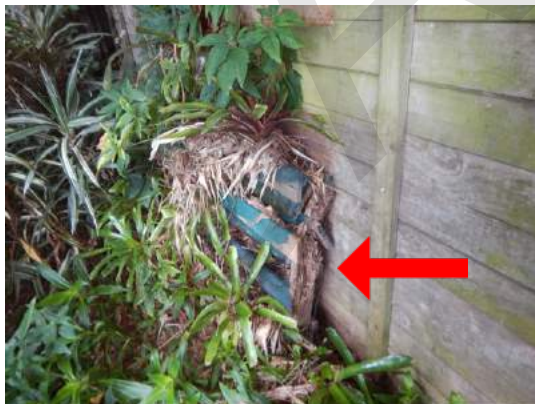
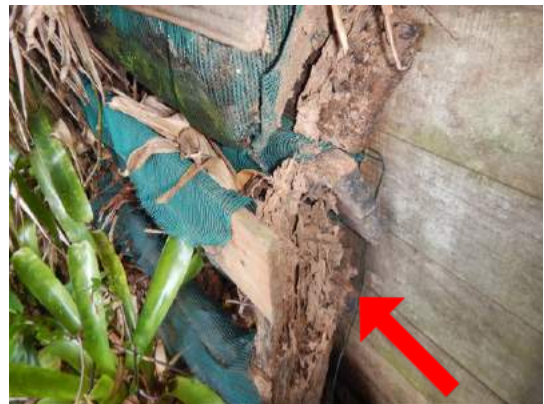
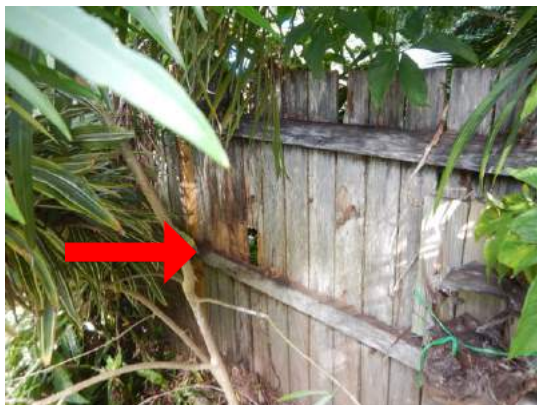
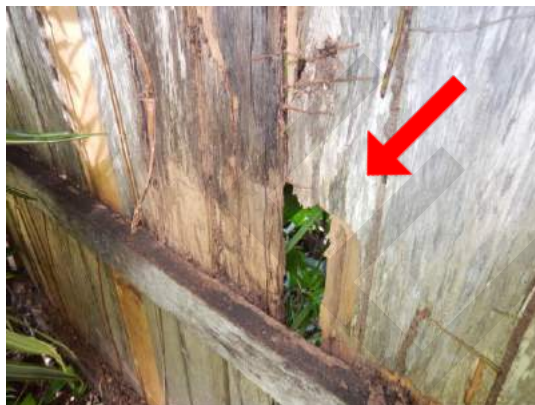
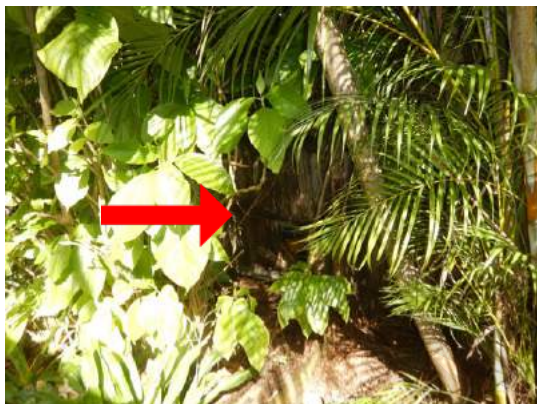
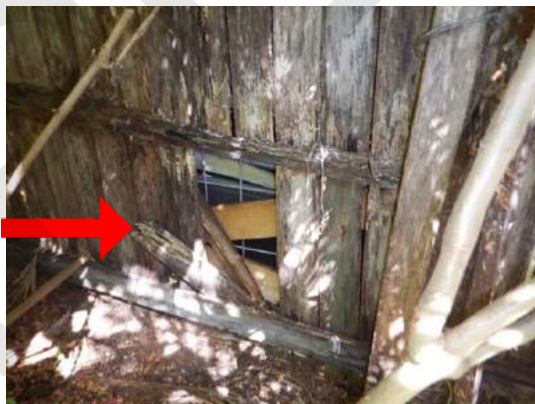
Finding 5.01

Location: Yard - Back

Finding: Evidence of termite damage - external

Information: Despite no live termite or timber pest activity being indicated, previous termite damage was found to have affected this area. This damage is considered to be inactive.

It is advised that the area be visually inspected frequently to ensure that the condition of affected materials does not worsen.

A fencing contractor may be appointed to repair/replace fencing where necessary. Old timber material that serves no purpose should be removed immediately.

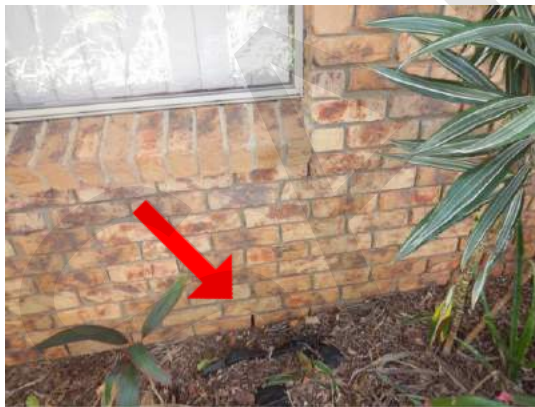
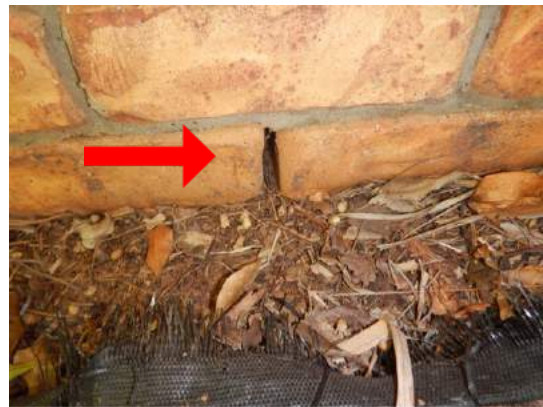
Finding 6.01

Building:	Main Building
Location:	Exterior walls - left side
Finding:	Bridging or breaching of termite barriers - weep holes
Information:	Bridging is the spanning of a termite barrier or inspection zone so that subterranean termites are provided with passage over or around that barrier.

Weep holes in the exterior brickwork of the property are designed to allow condensation that may build up between the brickwork and subsequent timber framework to drain from within the wall hence preventing any deterioration of the timber building elements.

Where weep holes are covered by external ground levels such as paving or garden beds concealed entry is available for termites from these grounds into the brickwork or external wall materials.

Additionally build-up of moisture is likely to occur if weep holes are covered further attracting termite activity to these areas.

It is recommended that weep holes are left exposed in all areas throughout the external property. Therefore if any termite activity leading into weep holes becomes easily detectable during frequent pest inspections.

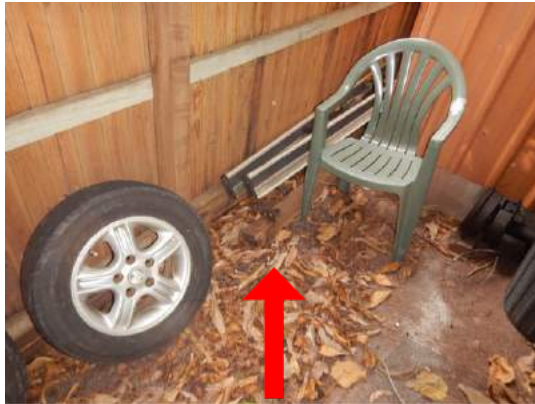
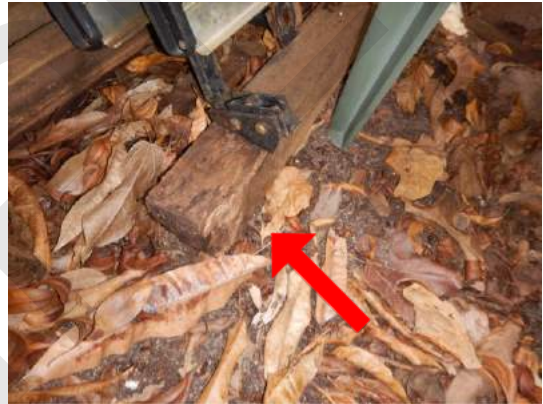
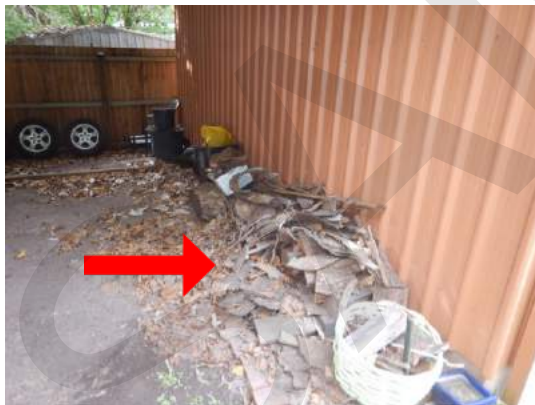
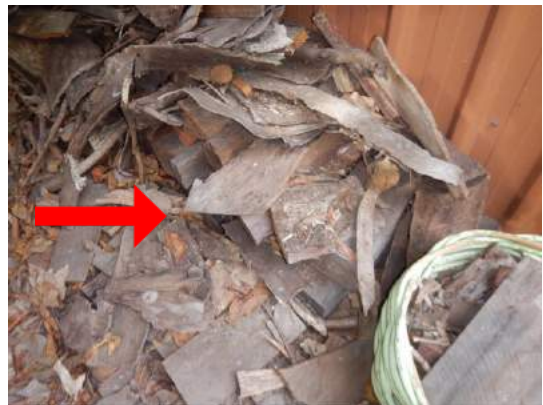
Finding 6.02

Location: Yard - Back

Finding: In ground contact

Information: Any timbers in direct ground contact provide opportunity for concealed termite entry and are likely to be subject to premature rot and decay as the soil retains moisture or damp conditions against the timbers.

Remove untreated timber that is in direct contact with external grounds. Frequent pest inspections are advised to readily identify any termite activity in these areas.

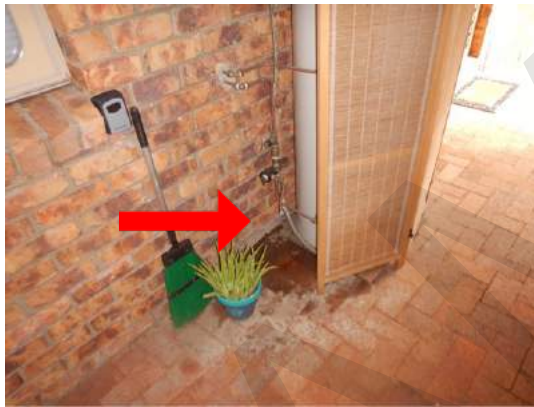
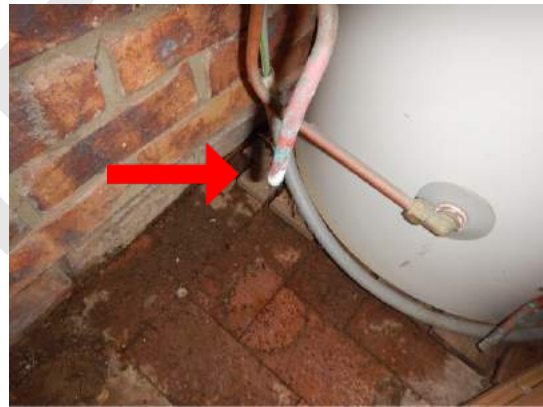
Finding 6.03

Building: Main Building
Location: Exterior walls - right side
Finding: HWS Overflow - Not Connected
Information: The Hot Water System (HWS) overflow was found to be disconnected from storm water drainage and is creating excessive moisture in the surrounding area.

These damp conditions can lead to secondary defects such as rot, rust or corrosion of associated building elements, the formation of fungal decay, or even the creation of potential slip hazards. When coupled with poor site drainage, pooling of water may also attract termite activity to this area.

It is recommended that a licensed plumber be appointed to connect the HWS overflow in order to prevent such an environment from being created. These minor works should be carried out as soon as possible.

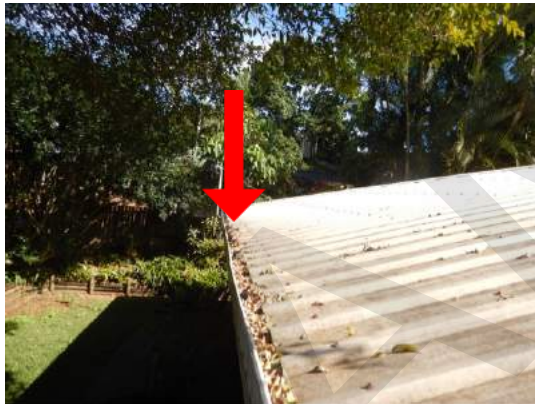
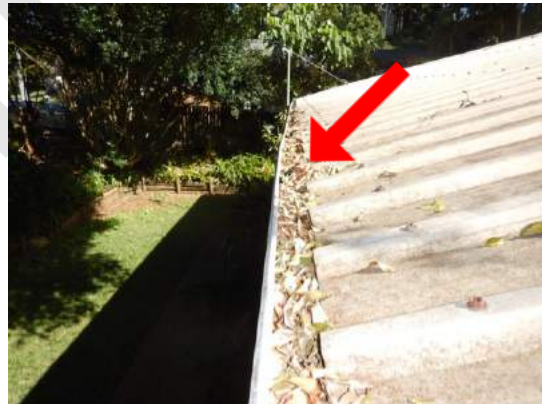
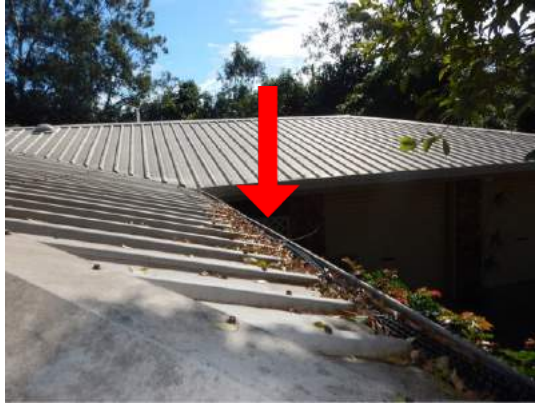
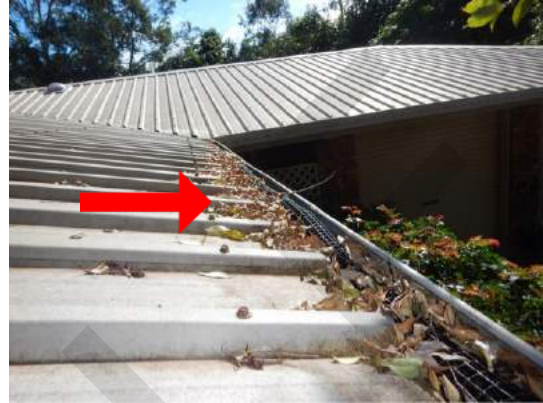
Finding 6.04

Location: Roof

Finding: Gutters - Blocked

Information: Roof plumbing structures, such as guttering and downpipes, should be free of all debris to prevent blockages. Blockages of the guttering and downpipes will lead to pooling and accumulated water overflows, which is likely to subsequently flood eaves and exterior walls.

Blocked gutters are likely to lead to high levels of moisture in the affected areas. Such moisture will not only cause rust and decay of the associated building materials, but can also provide conditions that are conducive to termite and timber pest activity. Blockages in gutters should therefore be removed to ensure dry conditions are maintained.

It is advised that blocked gutters be removed by the homeowner or a general handyperson as a matter of urgency.

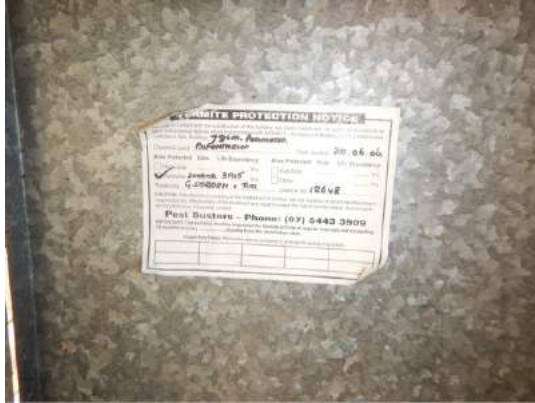
Finding 6.05

Location: Meter Box

Finding: Evidence of a chemical treated zone barrier was identified

Information: During inspection of the property, it was noted that works to install a chemical treated zone barrier had previously been completed. A chemical treated zone barrier is likely to ensure effective protection against termites.

However, we strongly recommend annual inspections of the barrier and surrounding areas as there are several factors that can lead to deterioration of the barrier and decrease its effectiveness.

Where a Termite Management System has been identified, the client should identify to the type of barrier, date of installation, warranty conditions and any documentation provided by a builder or past owner. Consult the company who installed the barrier to confirm whether the system is still under warranty.
